SUBJECT: LA-6 Model.

DATE: October 31, 1933.

We release herewith the third installment of Machine Service Bulletin No. 161, Plates 22 to 28 inclusive, which illustrate and describe how to adjust the mechanism not covered in the first installment of this Bulletin.

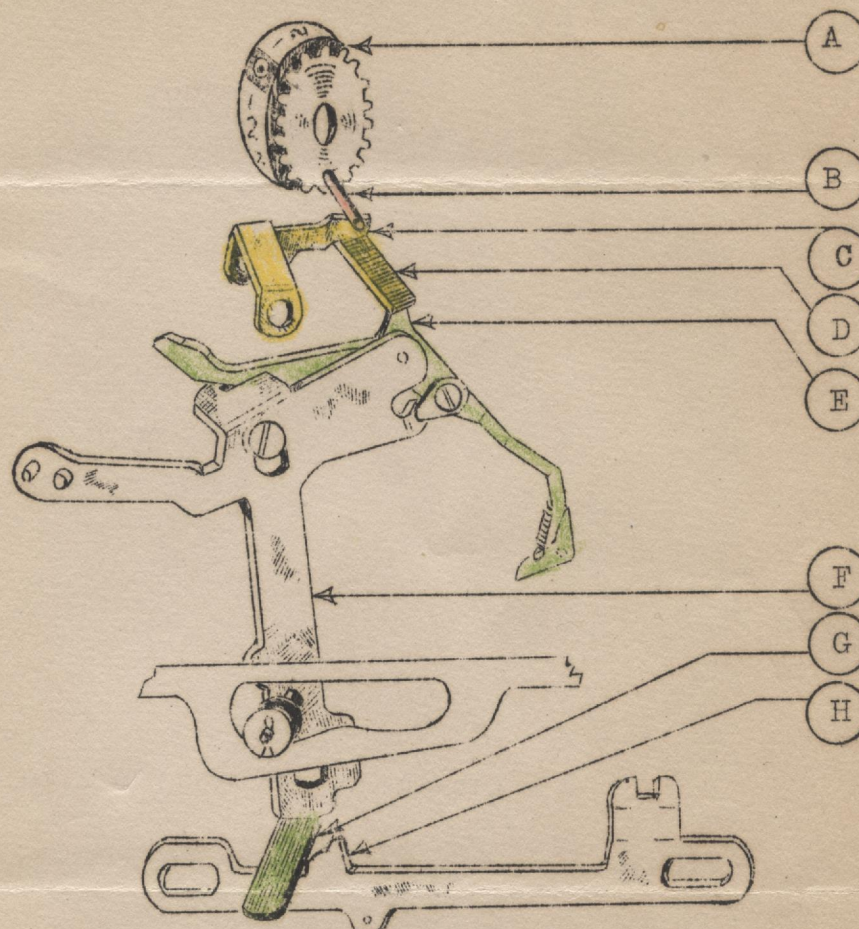
FIG. 1

At the completion of a problem in automatic multiplication, the figure "one" which remained in the upper right hand dial is replaced by the "zero", due to the lug (D) seating on (E), causing an upward movement of (C) which restores the pin (B) to its neutral position. The above operations occur only when lug (G) is latched on (H). If lug (D) is bent too low, dial (A) will not clear out when the carriage crank is turned. If lug (D) is not bent low enough, the zero will not return to its neutral position.

When the lug (G) is unlatched from (H), clearance of .010 should exist between the bottom of lug (D) and the tip of (E). This clearance is obtained by bending lug (D) upward or downward to suit.

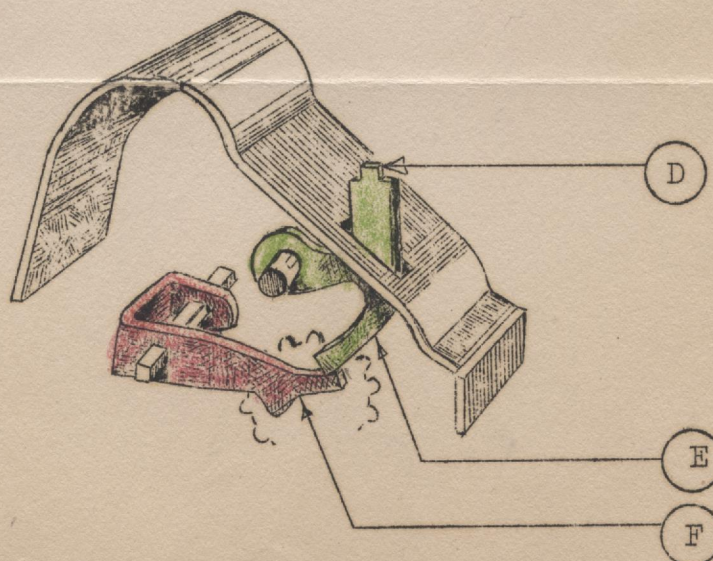
When the carriage is placed in any position with the exception of the extreme left and the constant key (D) is depressed, the lug (E) on the constant key (D) should engage the trip pawls (F) as shown. If the lug (E) fails to engage (F), bend the lug (E) with kit tool #14 until a direct alignment of (E) with (F) is obtained.

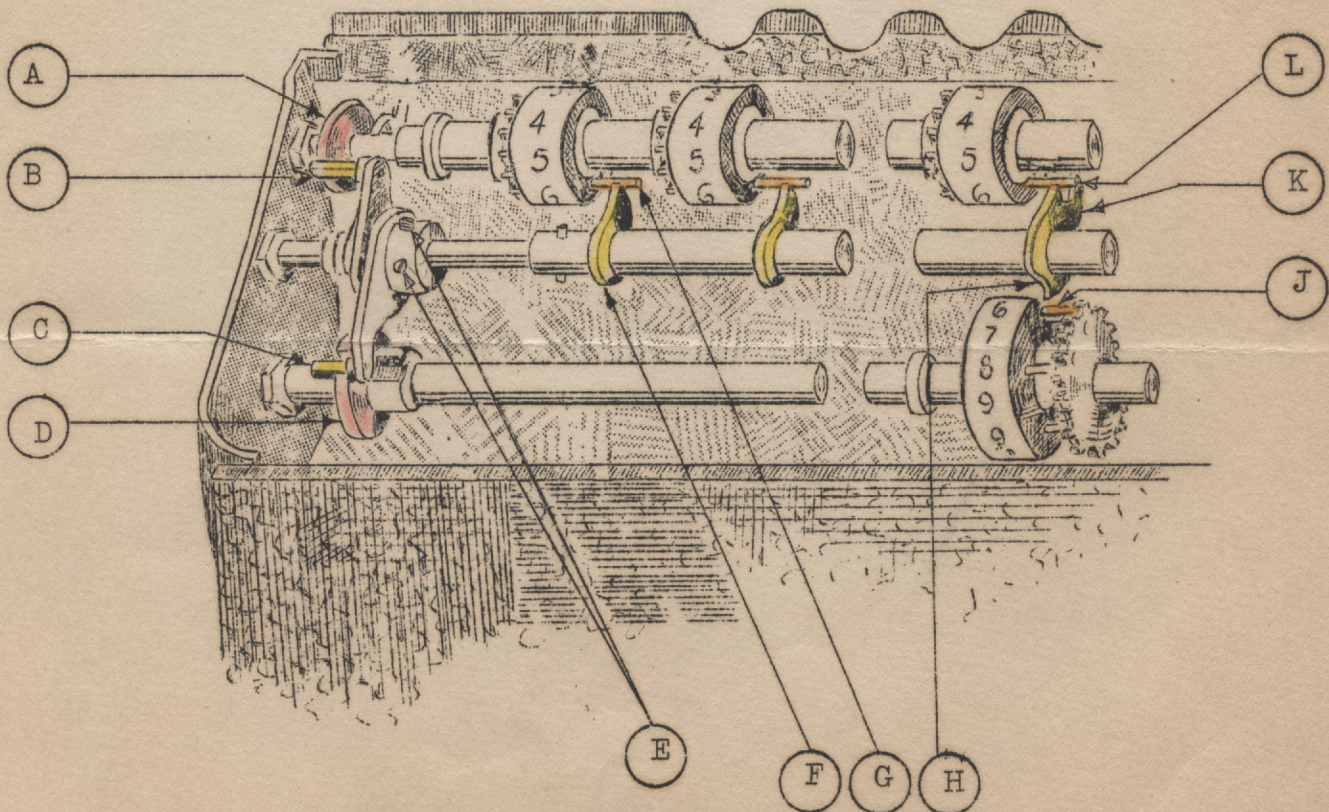
FIG. 4

Register figures in the lower dials; turn the carriage clear crank slowly and note the engagement of the fingers (F) and (K) with the clear pins (G) and (L). The fingers should engage the pins (G) and (L) with an approximate $\frac{1}{3}$ hold, providing extension (H) engages pin (J) while the upper dials are being cleared. Set screws (E) provide an adjustment of pins (B) and (C) in relation to cams (A) and (D) for regulating the hold of the fingers (F) and (K) on pins (G), (J) and (L).

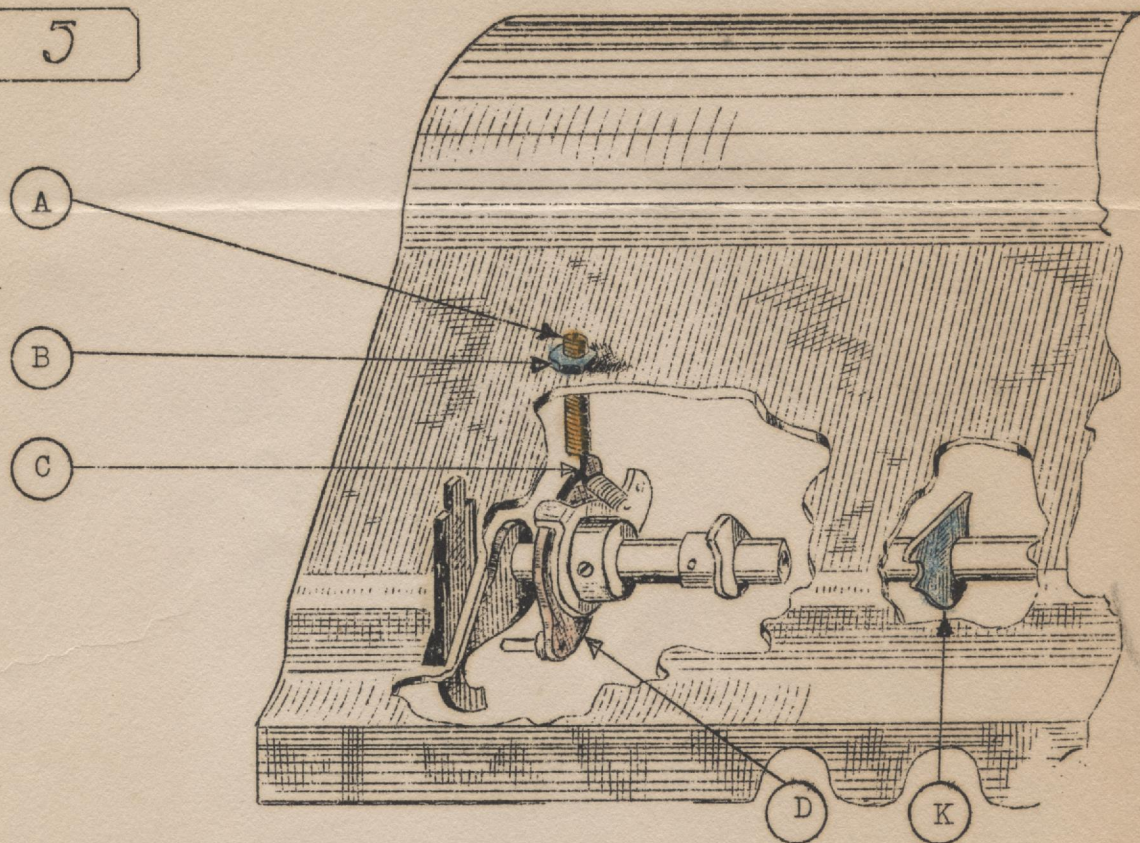
FIG. 5

Set screw (A) is provided to limit the movement of arm (C) and the trip rod locator assembly (D), thus controlling the position of pawls (K) in their proper relation to pin (L), Figure 4, Plate 24, when setting in a constant on the registering dials. After the correct adjustment has been determined, tighten nut (B) securely.

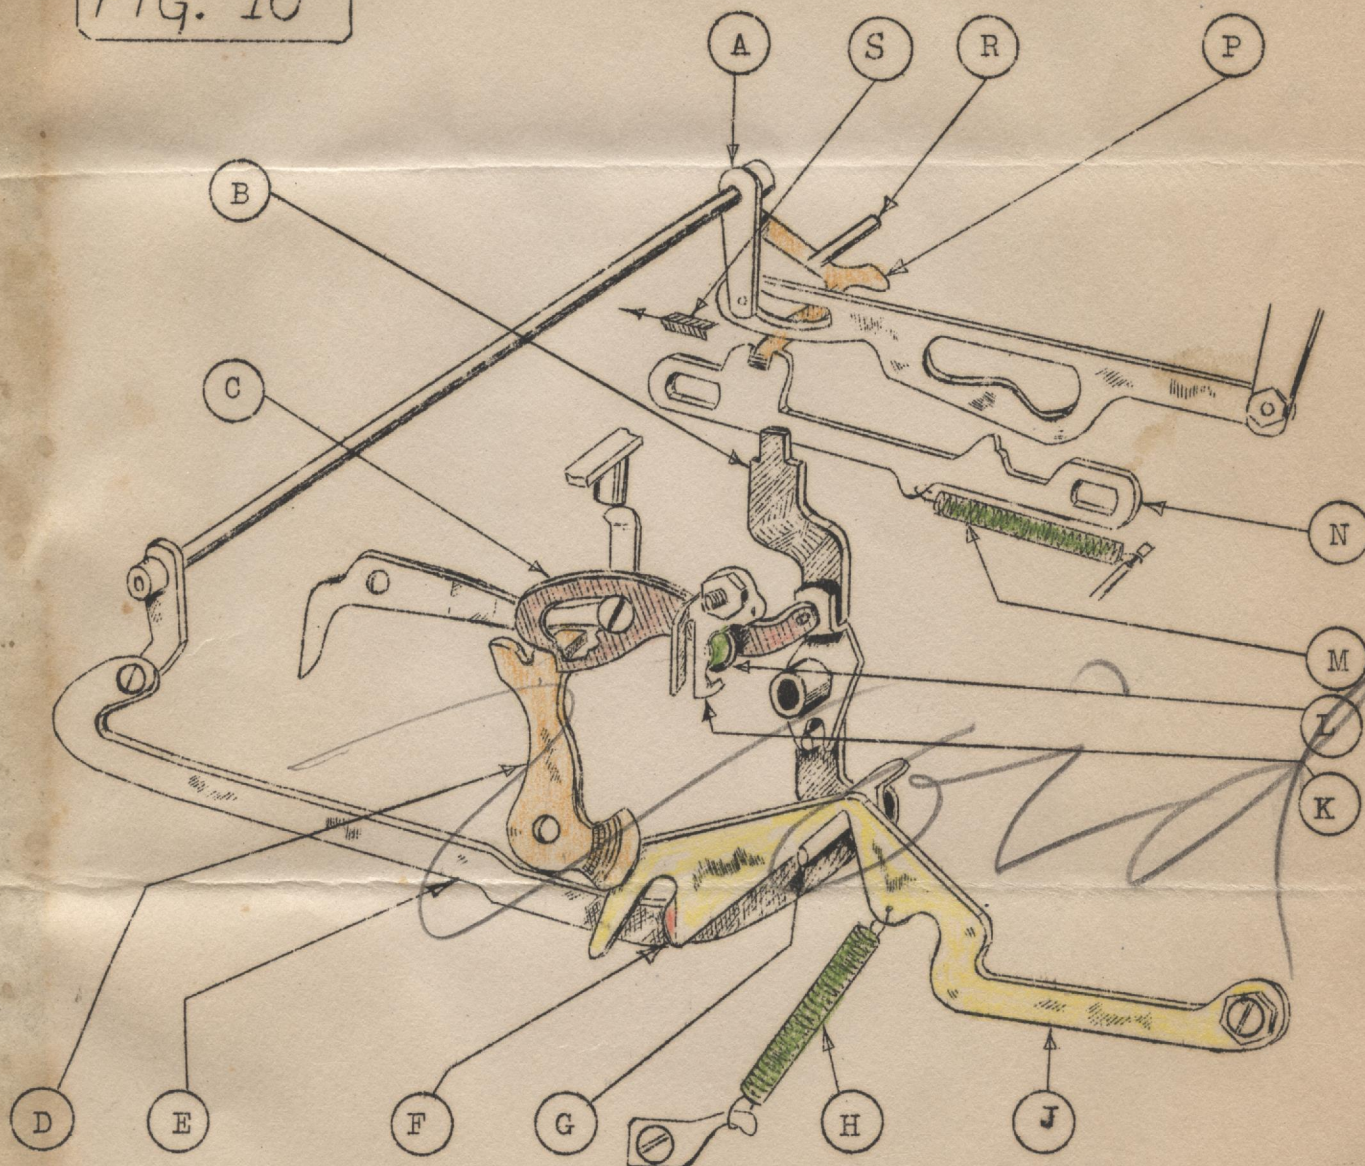
FIG. 10

To remedy a condition wherein the division lever (B) fails to restore or restores sluggishly, a button of .040 thickness (L) has been added to the guide blank (K). This prevents the blank (C) from camming out of engagement with the restoring arm (D) as shown.
